211 South Kent Street

Tax Map Number: 193-1-Q- 14-DHR Resource Number: 138-0042-0538 Resources: 1 single dwelling; 1 outbuilding; 1 shed Date/Period: ca. 1810 Style: Federal Sources: Sanborn Fire Insurance Company Maps; Quarles, *The Story of One Hundred Old Homes*

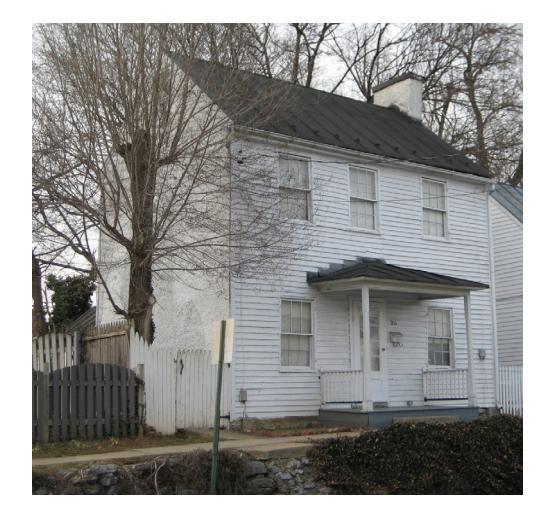
Primary Resource Description: This two-story, three-bay single dwelling has a form indicative of the Federal style. It is set on a solid foundation of coursed stone. The frame dwelling (possibly log), extending there bays wide and one bay deep, is clad with wood weatherboard siding on the façade (east elevation) and is stuccoed on the side (north and south) elevations. A side-gabled roof of standing-seam metal caps the dwelling and is pierced by an interior end, stuccoed chimney on the north elevation. A one-story, one-bay porch, constructed circa 1925, is centrally placed on the façade. The half-hipped roof is covered with standing-seam metal and is supported by chamfered wood posts with square balusters. The window openings on the façade contain 6/6, double-hung, wood-sash windows with narrow wood surrounds. A single-leaf, paneled wood door, centrally placed, is sheltered by the porch roof. This entry also has a wood-frame storm door with lights. A louvered wood vent is located in the upper gable end of the side (north and south) elevations.
