# City of Winchester

**524 South Loudoun Street**

DHR Resource Number: 138-0042-0799

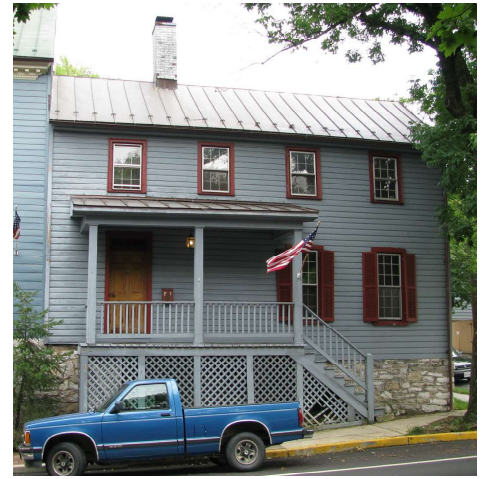
**Primary Resource Description:** This two-story, three-bay single dwelling is two bays deep and has a rectangular form indicative of the Federal style. It has been expanded by two rear additions. The wood-frame (or possibly log) building is clad in German wood weatherboard siding with corner boards. It is set on a solid, raised basement constructed of roughly-coursed stone. The building is capped by an asymmetrical, side-gabled roof covered in standing-seam metal. The roof is finished with overhanging eaves and a boxed cornice partially obscured by a metal gutter. An interior brick chimney with a plain cap pierces the ridge of the roof. The window openings on the first story of the façade (west elevation) contain 9/9, double-hung, wood-sash windows. The second story has 6/6, double-hung, wood-sash windows. Each window is set in a square-edged, wood surround. The first story windows also feature louvered wood shutters. The northernmost bay of the first story contains a single-leaf, paneled wood door. The door is set in a square-edged, wood surround with a five-light transom. This door opening is protected by a one-story, two-bay porch capped by a shed roof covered in standing-seam metal. The roof is supported by square wood posts. The porch is set on a wood pier foundation with lattice infill. The porch also features square wood balusters and wood steps. The south (side) elevation is fenestrated by 9/9, double-hung, wood-sash windows on the first story and 6/6, double-hung, wood-sash windows on the second story. The windows are set in a square-edged, wood surrounds. A small louvered metal vent is located in the upper-gable end. The north (side) elevation is obscured by 522 South Loudoun Street. The east (rear) elevation is largely obscured by two additions, however there is a 6/6, double-hung, wood-sash window in the southernmost bay of the second story.
