23 East Monmouth Street

Tax Map Number: 213-1-B- 22A-DHR Resource Number: 138-0042-0823 Resources: 1 single dwelling; 1 barn

Date/Period: ca. 1860 Style: Vernacular

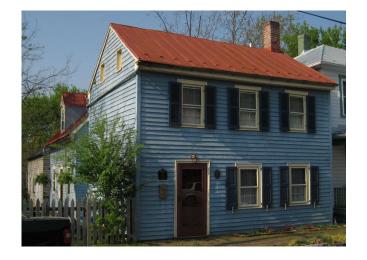
Primary Resource Description: This two-story, three-bay vernacular single dwelling was constructed circa 1860. Believed to be a log structure, the dwelling is clad with wood weatherboard siding and has wood corner boards. Set on a solid stone foundation of random rubble, the dwelling is capped by a side-gabled roof of standing-seam metal. The roof is finished with a boxed cornice and plain raking boards. An interior-end brick chimney rises from the west (side) elevation and pierces the roof at the ridge. The easternmost bay of the first story of the façade (north elevation) contains a single-leaf paneled wood door with an ogee-molded wood surround. The window openings on the façade contain 6/6, double-hung, wood-sash windows with ogee-molded wood surrounds. The first story windows have inoperable paneled wood shutters, while the second story windows have operable louvered wood shutters. The east (side) elevation is fenestrated with four-light wood casement window with square-edged wood surrounds.
