City of Winchester

2 North Cameron Street

DHR Resource Number: 138-0042-1096, 138-0045

Resources: 1 commercial building

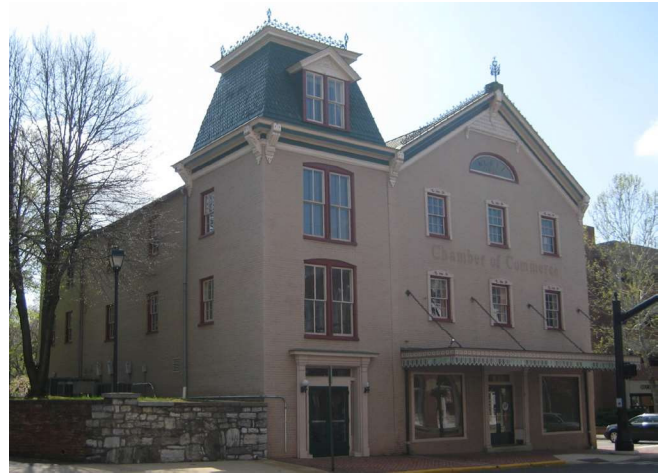
Primary Resource Description: The main block of this building is three-and-a-half stories high, three bays wide, and three bays deep. It is front-gabled with a rectangular form. Attached to the façade is a full-width overhang (canopy) with flat roof. North of the main block is a two-story addition (1), which is one bay wide and three bays deep. The western facade of this addition is capped with a mansard roof that elevates this portion to three-and-a-half stories. The rear of the main block has been extended another two bays with a three-and-a-half-storied, front-gabled addition (2). North of this addition and attached to the rear of the two-story north addition is a two-story addition (3) with a gently north-sloping shed roof. The overall structural footprint of this building forms a square.

Original Main Block: The original portion of the building, constructed circa 1836 (according to plaque), is set on a solid Flemish-bond brick foundation. This masonry structure is of Flemish-bond brick, which has been painted. The words "Chamber of Commerce" is faintly written in large letters across the west façade. The front-gabled roof is covered in standing-seam metal. It features an ogee-molded wood cornice supported by wood carved brackets and a decorative metal railing on the roofline. Above the gable peak is intricate scrolled decorative ironwork. The small area, at the very top of the gable ends, is clad with a carved wood design, imitating brick header stringcourses. This section is delineated from the exposed Flemish-bond brick of the building by a thin ogee-molded wood cornice supported by modest wood-carved brackets. The façade of the main block is very ornate. The first story features two one-light, storefront windows set within square-edged wood surrounds with engaged wood columns. These flank either side of the central double-leaf glass door. This entry has a one-light wood transom and is set within a wood Colonial Revival-style surround consisting of engaged columns and ogee-molded cornice. Sheltering the first story is a flat-roofed awning held with metal tie-back chains. This awning is of wood construction. The decorative scalloped cornice is constructed of wood inset with colored glass. The second- and third-story windows are symmetrically fenestrated. Each is 6/6, double-hung, wood-sash set within square-edged wood surrounds. They are topped with splayed brick jack arches. The surrounds and jack arches are largely obscured by carved wood surrounds that are fluted and decorative carved wood lintels. Within the upper gable is a one-light lunette window set within an ogee-molded wood surround. This window has painted lettering: "Kurtz 1836." Only the south elevation of the main block is visible because large additions have been added to the east rear and north side elevations. The first story of the south elevation features three large, one-light, storefront windows. They are framed by Colonial Revival-style wood surrounds with ogee-molded architrave cornices. These openings are not original. The first and second stories of the south elevation are symmetrically pierced by three bays of 6/6, double-hung, wood-sash windows set within square-edged wood surrounds. Each has a wood sill and a splayed brick jack arch.
